# UT Hiwassee River

Year 1 Summer – August 2008

UT Hiwassee River  
R-977A  
Cherokee County

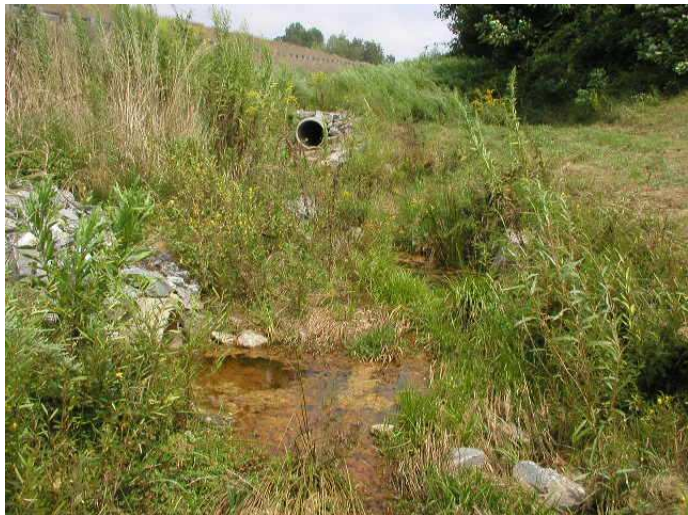
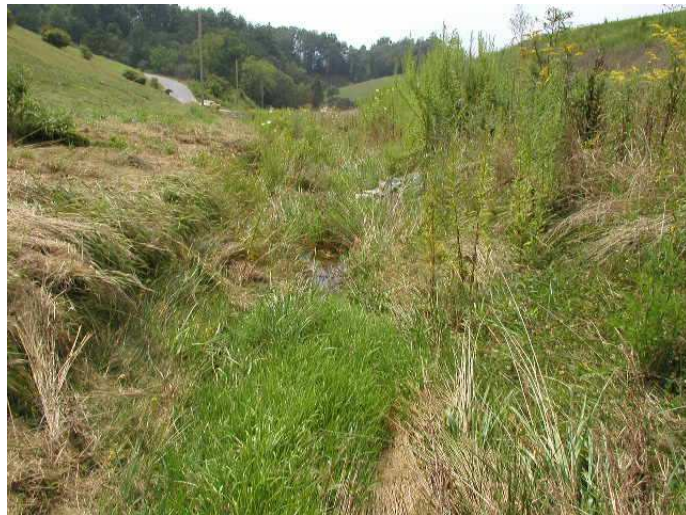
Photo Point #1 (Upstream)

The buffer area upstream of the church driveway culvert (Photo Points 1 through 4) has continued to be mowed. The Residence Office plans to notify the church again about not mowing this area. Planted vegetation is minimal along this section of the stream relocation.

Estimated causes, and proposed/required remedial action: Some additional planting of pussy willow and redtip dogwood was completed downstream of the church driveway culvert. The entire site should be completely planted by December 2008.

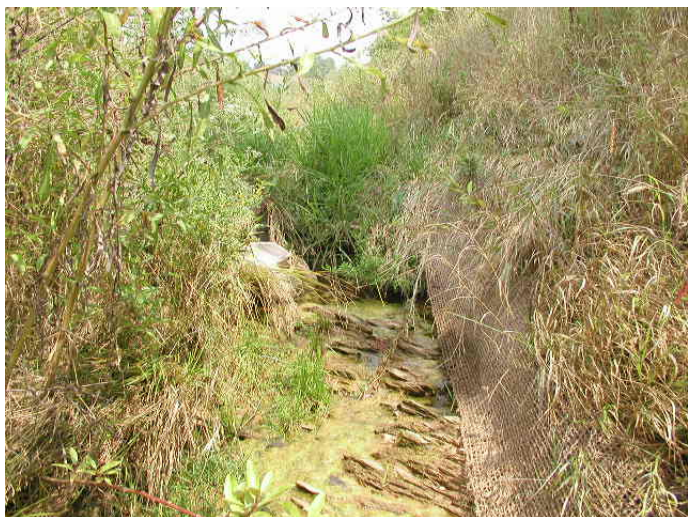
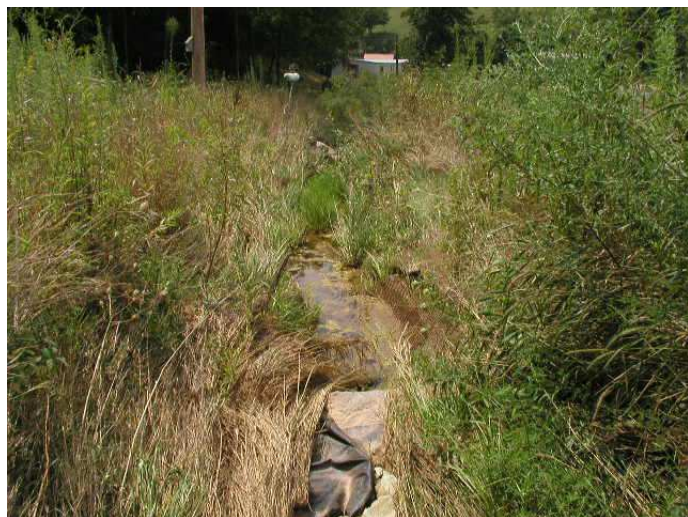
Photo Point #7 (Upstream)

Date Inspected 8/13/08	Station 13+20 PP#7 Downstream Photo	Station 13+00 PP#8 Upstream Photo	Station 13+40 to 13+80 Between PP#5 and PP#6	Station Number	Station Number
Structure Type	Crossvane	Crossvane			
Is water piping through or around structure?	Water piping under crossvane	Water piping under crossvane	Water piping bypassing stream bed underground where blasting took place		
Head cut or down cut present?					
Bank or scour erosion present?					
Other problems noted?
